## EPA Region 7 - Iowa AFO/CAFO Inspection Review Checklist

SUBJECT: Confinement Compliance Inspection for PI-239, Poweshiek County, Facility #65498

**IOWA DEPARTMENT OF NATURAL RESOURCES  
CONFINEMENT INSPECTION REPORT**

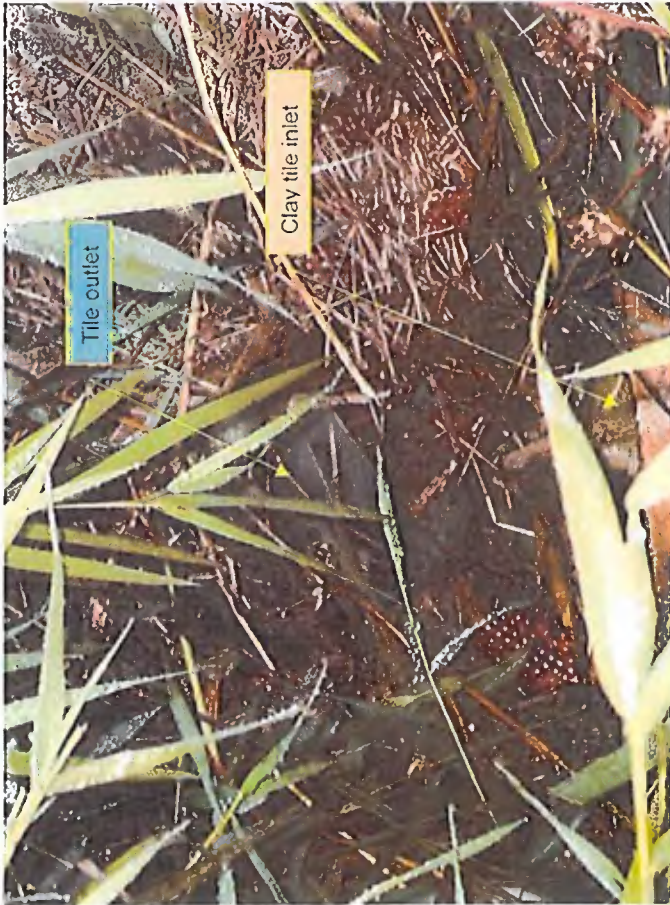
-The building's footing drain tile outlets to the NE of the NE corner of the building, which no moisture was observed during this inspection. The tile (picture) would out let in a small hole/depression, then less than a foot away is a clay tile and any moisture would flow directly into it (no outlet for the clay tile was noted). Since this outlet is not truly day lighting on-site Prestage Farm needs to install a shut-off valve on the tile and establish a permanent observation structure around this hole/depression, this way it doesn't get covered up.

Perimeter tile out letting to a clay tile.

- Install a shut-off valve on the building's footing drain tile and establish a permanent observation structure around this hole/depression, this way it doesn't get covered up.
- Properly dispose of all the solid waste of ash that has accumulated at the site.
- A sure that your applicator is commercially licenses.

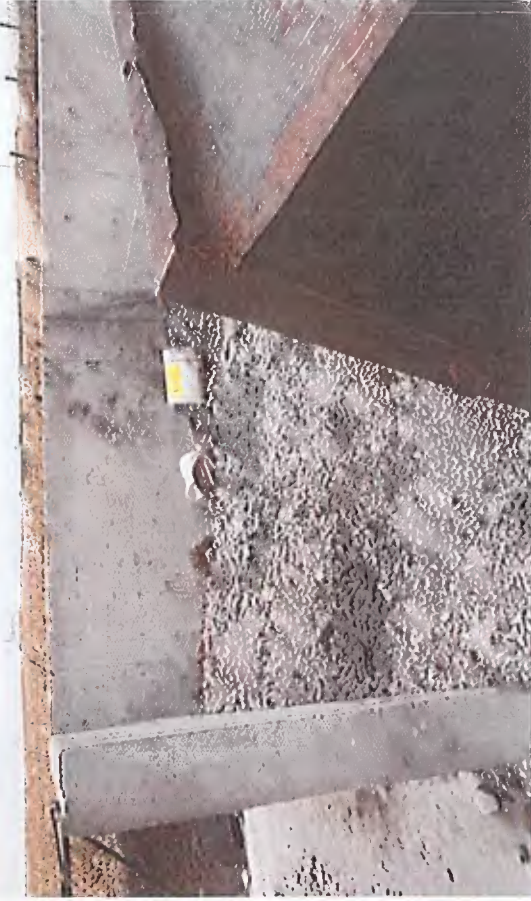
-The incinerator is no longer used and rendering is, but there is a lot of ashes left in your control area (3 walled cement area -picture) that needs to be properly disposed of. Once this is done then the dead box can be placed inside for extra protection and control of your disposal of deads.

Ashes from incinerator should be properly disposed of so the dead box can be placed inside this area for extra control/protection.
